Hawker Siddeley Electronics Limited

FERRIS PRODUCTS DIVISION

BULLETIN TO FERRIS CAR RADIO SERVICE CENTRES:SUBJECT:

## SLIPPING MANUAL TUNING CONTROL

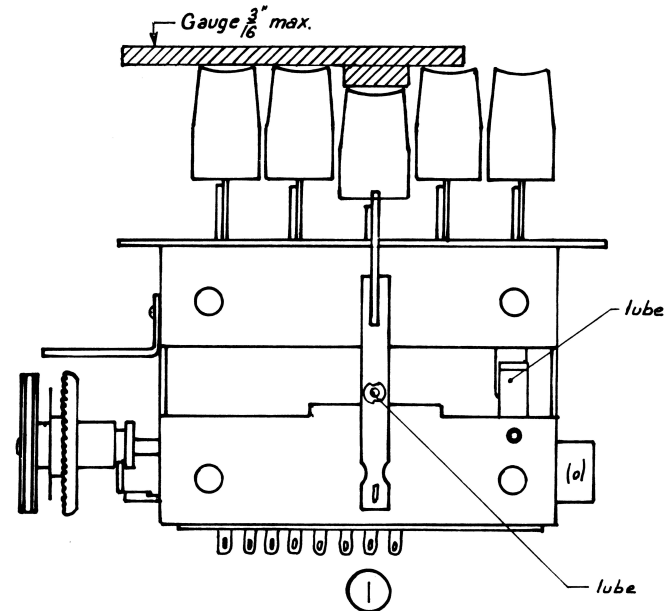
When fitted with M.S.P. tuners, some cases of failure of manual tuning drive due to clutch slip have occurred in the above models.

1. Test for free play in button movement. For correct clutch operation, from 1/8" to 3/16" free play should exist (see Fig. 1.)
2. If button free play is less than 1/8" bend clutch lever, using long nosed pliers or a suitable tool, to the angle shown in Fig. 2. — 92° to 95° approx.
3. Check tension on rocker shaft springs on each side of tuner. If excessive, bend spring as shown in Fig. 3., using a screwdriver to relieve pressure.
4. Apply a small amount of soft grease to all friction points. (See arrows marked 'lube' — Figs. 1 & 3).

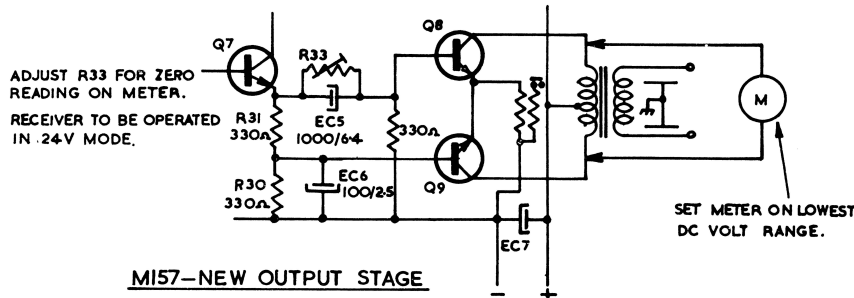
**M157-NEW OUTPUT STAGE****FERRIS BROS. PTY. LTD.****BULLETIN TO FERRIS CAR RADIO SERVICE CENTRES:****SUBJECTS:**

When M157 bus sets are returned for service due to transistor failure in the output stage, the following modification should be implemented (refer to M157 circuit diagram):-

- (1) Replace 2N3055 transistors.
- (2) Change resistors R30 and R31 from 150 ohm to 330 ohm ½ watt 10%.
- (3) Disconnect choke L6 (8132) from circuit.
- (4) Fit a 330 ohm 10% ½ watt resistor from negative rail to base circuit of Q8 (install resistor on printed circuit board).

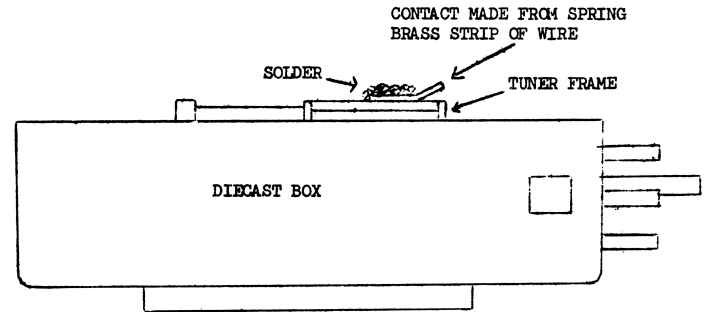
FIGURE 1

If, after fitting normal suppression to a vehicle, ignition interference is still a problem, the following points should be checked.

If interference persists, remove plastic rear lid from set and check fit of die cast lid on module box. This lid must make a firm electrical contact around its perimeter. This is especially important around the area near the push button switch. In stubborn cases, a small contact soldered to the top of the tuner frame and arranged to contact the under side of the die cast lid will help. See FIG.1.

- (a) Ensure a good earth return exists between cradle frame and car body. This is particularly important in the case of vehicles with non-metal dashboards. In such cases an efficient earth via the cradle rear mounting bracket is essential.
- (b) Check alignment of phosphor bronze wire contacts of cradle. Ensure particularly that cradle earth contact is entering the clearance hole in the base of the set to give an effective earth to the die cast module box within the receiver.

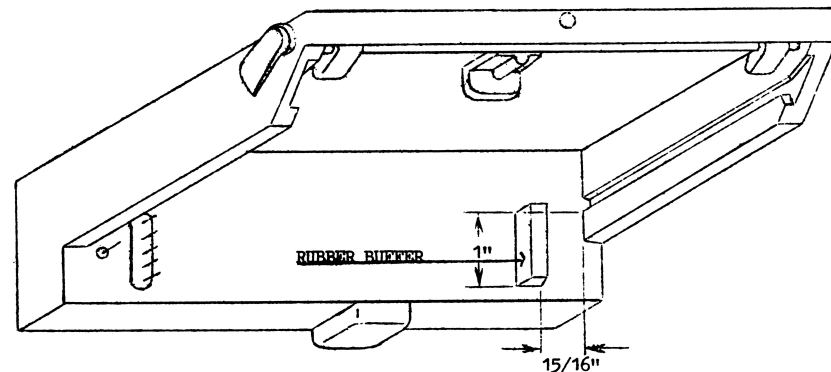
FIGURE 2

Early production Model 304 power cradles did not incorporate a rubber buffer to equalize forward pressure on both sides of the receiver base. Details of the modification now introduced in production to rectify this problem are as follows -

- (a) Obtain a pre-cut buffer - Part No. R2910 - or cut one from Dunlop Sponge Rubber Weather Strip (section A27).
- (b) Attach buffer to power cradle in the position shown in FIG.2 using a suitable contact adhesive.
