11 - 21 STURT STREET, SOUTH MELBOURNE.AUTO RADIO SERVICE BULLETIN.SUBJECT - ELIMINATION OF IGNITION INTERFERENCE  
1936-37 LA SALLE AND CADILLAC.

AUTO RADIO SERVICE BULLETIN.

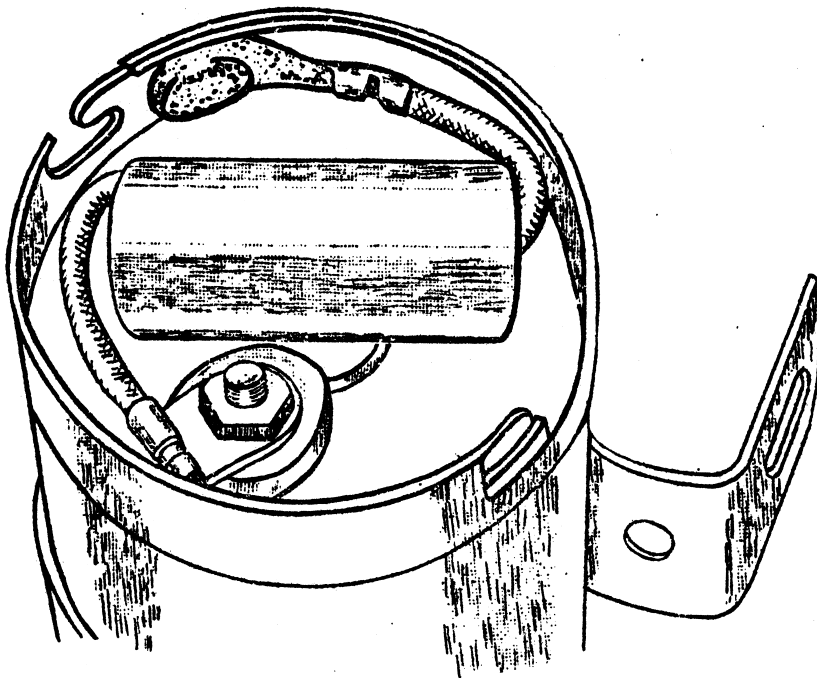
10. The foregoing procedure should result in satisfactory elimination of the ignition noise, however, if job is not satisfactory, a condenser should be installed in the rear of the ignition coil as illustrated below. (This will eliminate the need for condenser installed at ammeter).

To install condenser, remove the end cover of the coil. Place the condenser in the position illustrated, soldering the flat-tip terminal to the coil case. Attach the condenser eye terminal to the primary terminal of the coil. Replace the end cover.
