RADIO CORFORATION PTY, LTD.

Bulletin E-14. Page 1.

AUTO RADIO SERVICE PULLETIN.

SUBJECT - ELIMINATION OF EXCESS CRACKLE WITH ENGINE RUNNING.

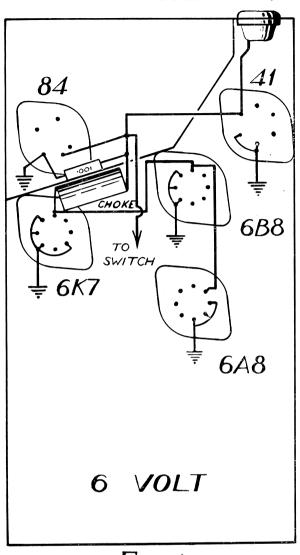
This complaint may be noticed in Model 6395 numbering up to 36,300 and Model 12595 numbering up to 44,011.

Except in extremely bad cases, this crackle is only noticeable when the aerial is disconnected, and is distinct from engine pickup, in that the frequency of the crackle does not vary appreciably with varying engine speeds, but is nevertheless, only present while the engine is running.

- 1. Fit a small has choke (PT137) in Model 6395 filament circuit to isolate the first three tubes (6A8, 6K7 and 6B8) from the rest of the filament and field circuits, and a .00lmfd. mica condenser from the "A" side of the choke to chassis as shown in Fig. 1. In Model 12395, the hash choke will isolate only the 6A8 and 6K7 filaments as shown in Fig. 2.
