Heathkit Troubleshooting Tips

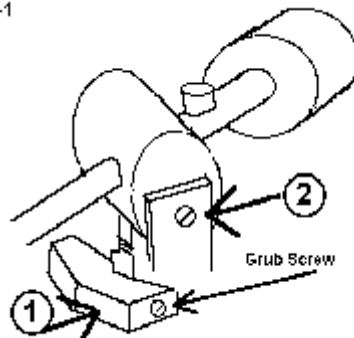
Figure AD-1

- **Tone-arm won't clear raising pad, cuing lever operation jerky (see Figure AD-1):** At first appearance, it's the rising pad (location 1), however, check the pivot screw (2) to make sure it isn't too tight (this also has some effect on tone arm setdown).

- **Tone-arm behaves normally halfway across LP, then sticks--playing the same groove over and over. Manually moving the tone arm inward about 1/2" fixes:** This is due to grossly misadjusted anti-skate

adjustment, causing the antiskating spring to latch on to one or more protuberances.

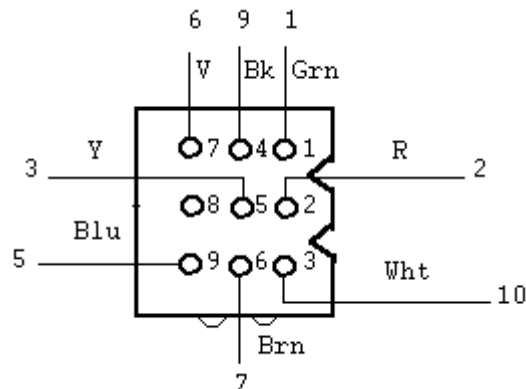
- **No scroll:** Check for interchanged blue and green wires to S503-5 and -6 beneath the picture tube. Green should go to S503-5.
- **P603 pin-out (rear view):**

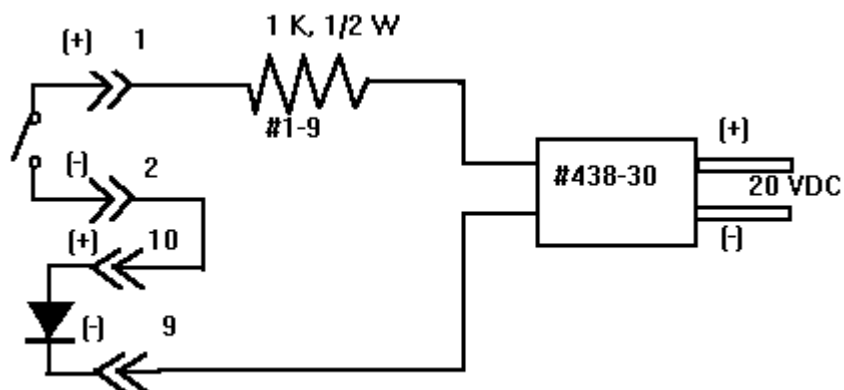
- **20 mA current loop (passive):**

- I'm not sure how I used the above circuit to test the H9 20 mA passive current loop function. Apparently, I plugged the dual banana connector into a 20 VDC power supply and did something with the switch. The

switch may represent a keyboard key and pressing it would echo the character back to the screen. (*ww 6 July 1996*)

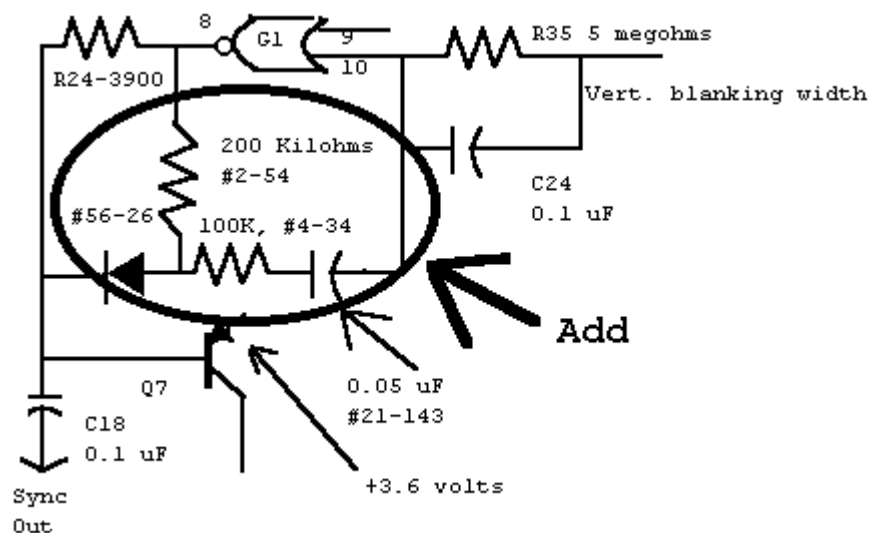
- **Excessive bend in vertical lines at top of screen with signal being injected through tuner--present mods don't help:** Install the following change:
