SERVICE NOTES

Service Bulletin FSN-30

Subject: NC-300 Changes

Service Bulletin FSN-32

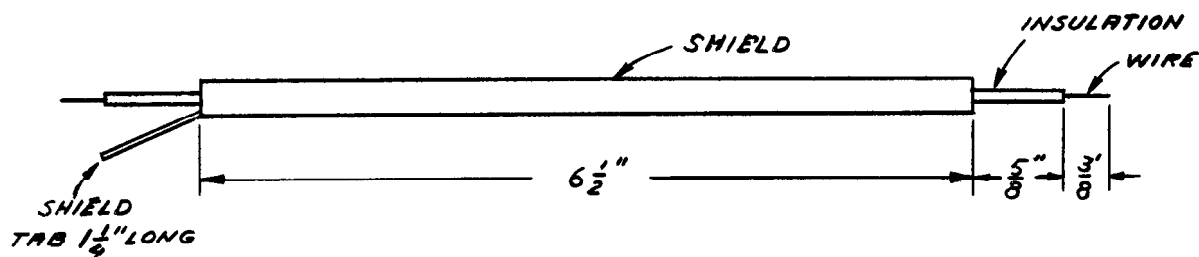
1. Unsatisfactory attenuation of spurious responses 40 kc. ($\frac{1}{2}$ the 80 kc. I.F.) removed from a strong signal's frequency.
2. Crystal filter improperly aligned for satisfactory bandwidth in the three crystal positions.

When measuring the magnitude of the spurious response, it is necessary that the antenna trimmer and the phasing capacitor be set to the true signal frequency and not to the spurious frequency.

A shielded lead should be constructed as shown below:

- A. Replace shielded lead from L4 to grid of second converter, V3 with above lead, placing it under phasing control shaft as shown in the pictorial diagram below.

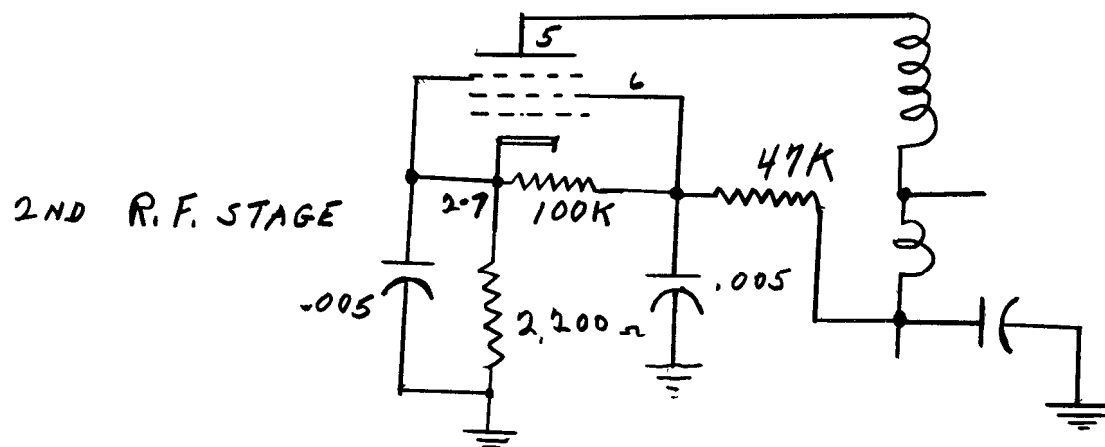
The following changes are recommended in the 6-meter converter to reduce cross-modulation:

Change cathode resistor in 6AK5 2nd R.F. amplifier stage from 470 ohms $\frac{1}{2}$ watt to 2200 ohms $\frac{1}{2}$ watt

A 100,000 ohm $\frac{1}{2}$ watt resistor should be connected between Pin #6 and Pin #2 - 7 of the same 6AK5 2nd R.F. stage

Revised circuit below:

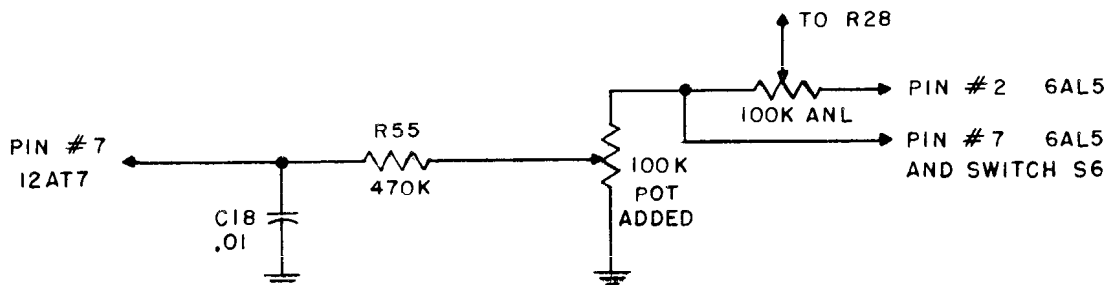
Some users of the NC-300 have complained about the fact that the "S" meter on the NC-300 seemed too sensitive. This may be adjusted in two ways to satisfy the individual user.

1. To decrease sensitivity of the "S" meter by a fixed amount, decrease the value of R-30 (68K 1/2 watt).
2. To decrease or increase the sensitivity of the "S" meter by a variable amount, replace R-43 (33K 1/2 watt) and R-30 (68K 1/2 watt) with 100 K potentiometer, connect arm of potentiometer to R-55 (47-OK 1/2 watt).

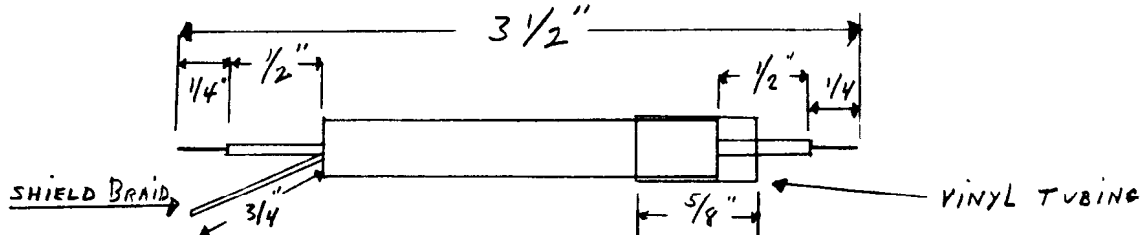
Subject: Additional Notes on Reduction of Spurious Responses
and B.C.I. in NC-300 Receivers

1. One shielded cable should be substituted for the blue lead connecting the plate of the first mixer (V2 Pin No. 9) to T3 (B). Drawing of cable below. The vinyl tubing is used to prevent grounds to other sections of the circuitry. Shield tab can be connected to the slug cup of L2-A which should already be grounded in accordance with FSN-33. It may be necessary to repeak L2-A after installation of this shielded lead.

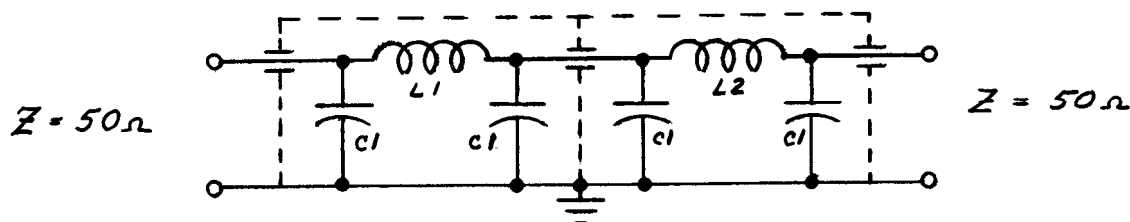
In certain metropolitan areas, I.T.V. is experienced on the 21 mc, 28 mc and X bands of the NC-300. This can be minimized by proper selection of antenna and the use of a low pass filter shown in the diagram below. This filter should be inserted in series with the antenna and located as close as practicable to the antenna terminals on the back of the chassis. A good earth ground helps considerably.

L_1 = .4 uh 10 Turns #20 on 3/8" form spaced 1/2"

C_1 = 80 uuf Ceramic

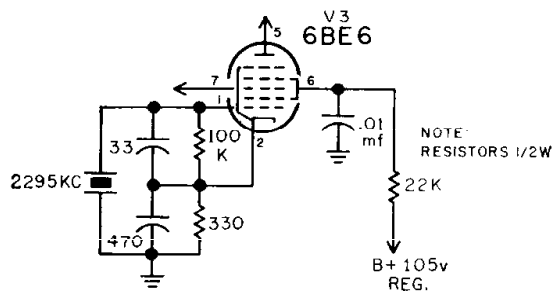
Fig. 1—Crystal controlled second converter.

The summer months of the year occasionally bring reports of calibration errors and ineffective crystal filter action in the NC-300, particularly in areas of high humidity. This is due to the second conversion oscillator drifting off its normal frequency of 2295 kc. This situation is evidenced by calibration errors on the dial in one direction on the high frequency ranges and in the opposite direction on the low frequency ranges and also by erratic operation of the crystal filter.

It is a simple matter to crystal control the second converter oscillator which effectively eliminates these problems.

The crystal and its associated components may be mounted in the shield can which formerly housed L6 the second conversion oscillator coil.

It should be remembered that there are now two crystals in the circuit which must be properly coordinated if the receiver is to work at maximum efficiency. Normal production tolerances in the grinding of the crystals may allow a situation to exist where the difference in frequency of the crystal in the filter (2215 kc) and the crystal in the second conversion oscillator (2295, kc) is not exactly 80 kc (second IF). If this is so the second IF strip must be adjusted accordingly, either slightly higher or slightly lower in frequency to compensate.
