# AIR CHIEF

## SERVICE DATA

C14N-2

### PN — C14N and MN — C14N

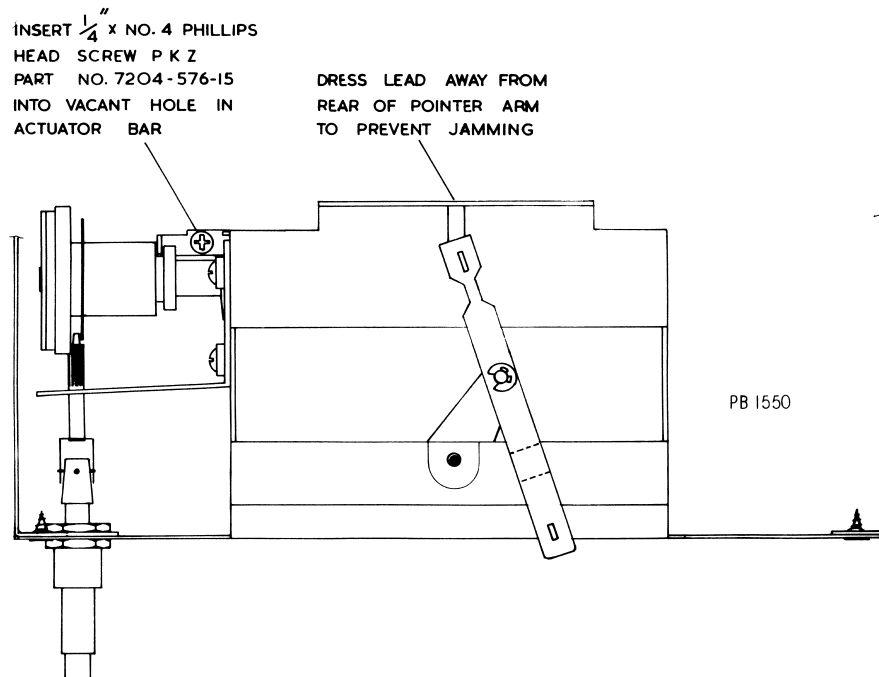
### ACTUATOR BAR - PUSH BUTTON TUNER

To prevent the actuator bar from moving out of position, a screw is now being inserted into the bar at the end nearest the clutch.

A  $\frac{1}{4}$ " x No.4 self tapping screw is to be inserted into the vacant hole at this location during service.
