Service Manual

36910A

Correction to Service Manual/Information

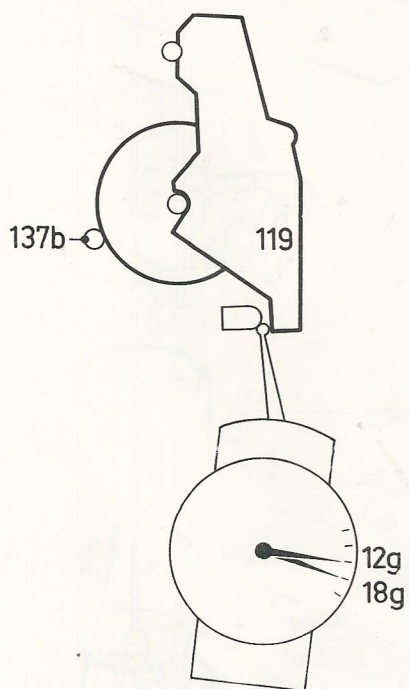
Fig. 13

- Check acc. to Fig. 13.

The pressure of the pressure roller cannot be adjusted; in case of a deviating value spring 507 should be replaced.

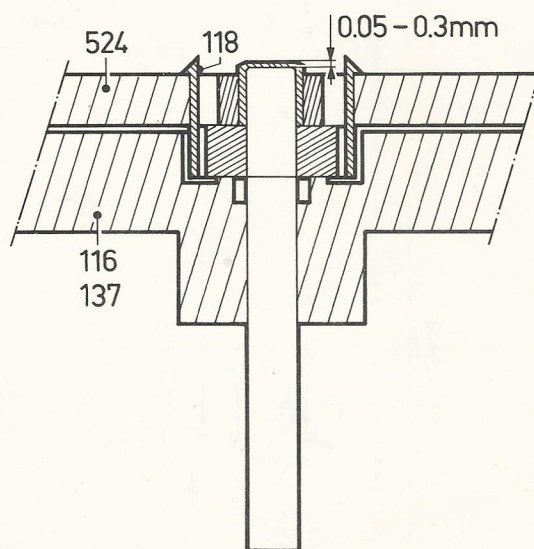
Fig. 14

- See Fig. 14.

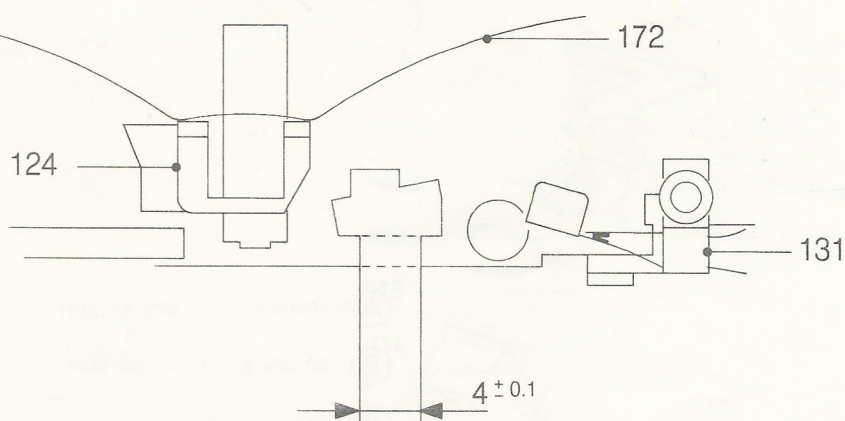
Fig. 1

- A85-317 mentions that the production method of latch lever 134 has been changed. At the same time, however, an additional rib has been added and the clearance in chassis 512 locally increased. As a result it is impossible to mount a changed latch lever in an unchanged mechanism. There are two solutions:
 - a. Enlarge clearance in chassis by means of metal saw and a smooth file. See Fig. 1.
 - b. Replace the complete mechanism (order number 4822 701 10123).

- Enlarge clearance in chassis by means of metal saw and a smooth file. See Fig. 1.
- Replace the complete mechanism (order number 4822 701 10123).
