AUTO RADIO SERVICE BULLETIN.

SUBJECT: FITTING 6 VOLT DISTRIBUTOR SUPPRESSORS.

RADIO CORPORATION PTY. LTD.,
STURT ST.,
SOUTH MELBOURNE.

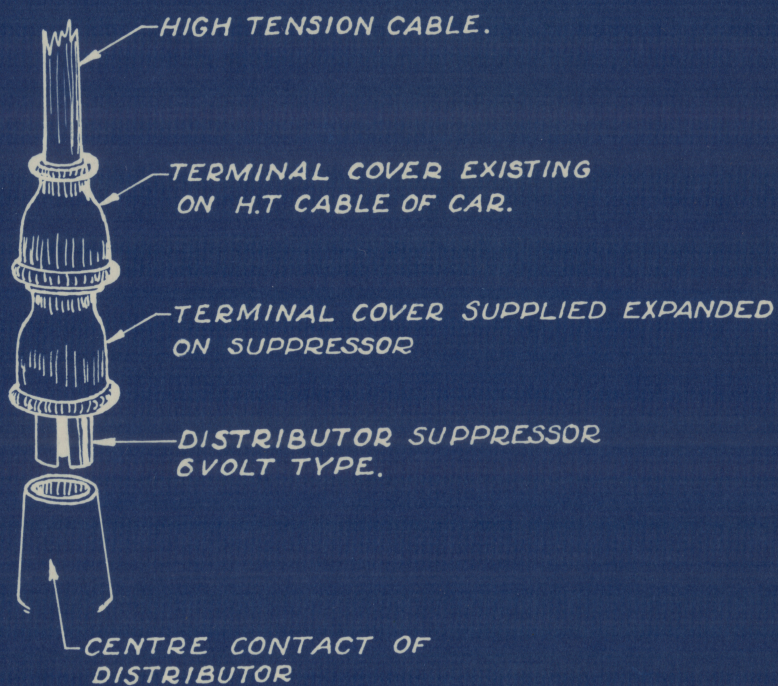
Trouble has been experienced with General Motors and other cars, with starting after radio has been fitted which was alleged to be caused by moisture getting into center connection of Distributor and suppressor fitted to same.

To overcome this the factory are in future fitting a Rubber terminal cover to each 6 volt suppressor so that the cover makes a shield to distributor when suppressor is plugged into distributor.

The existing terminal cover on the distributor is then used to shield the suppressor by threading on high tension cable and brought down over suppressor when connection is completed to same.

The arrangement is further described on Blueprint herewith.
