# Vintage Radio

Published: 20 July, 2002

The Airzone 500 series receivers.

By Rodney Champness

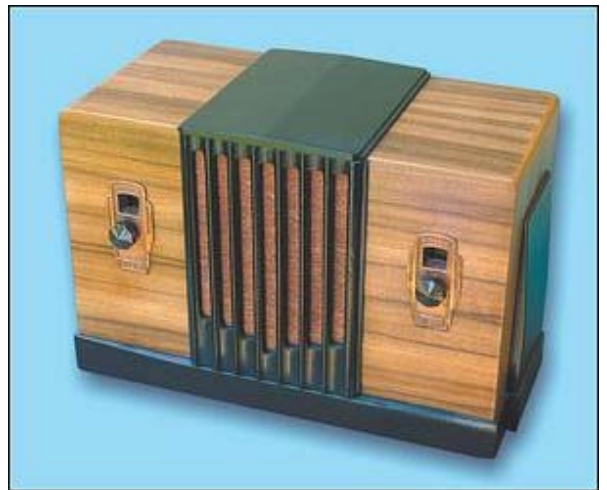
The Airzone 500 came in a stylish cabinet and has just two controls: volume and tuning. The control settings are visible through "peep hole" escutcheons.

but the tuning control is another matter. Due to the small size of the knob and the direct drive to the tuning capacitor, tuning is a finicky job at best.

The controls are back to front to what we've become used to, with the tuning on the left and the volume on the

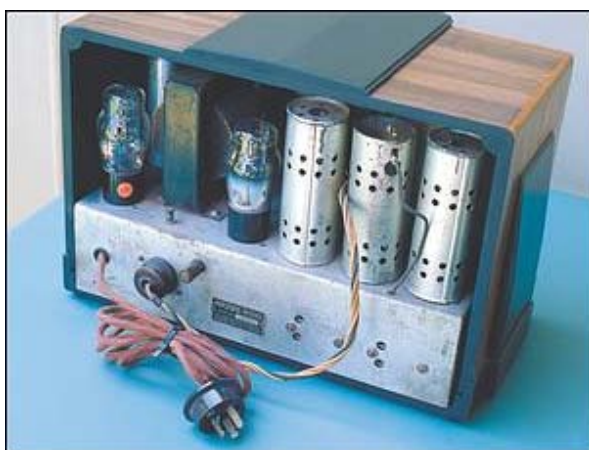
This view shows the rear of the cabinet, with the chassis in place. Loosening two screws underneath the cabinet allowed the chassis to slide out for servicing.

To remove the chassis from its cabinet, it is first necessary to remove the two knobs and the two bolts from underneath the cabinet. One interesting feature here is the fact that the bolts are located in slots. When loosened, this allows the chassis to be partly withdrawn so that valves may be replaced, as can be seen in one photograph.

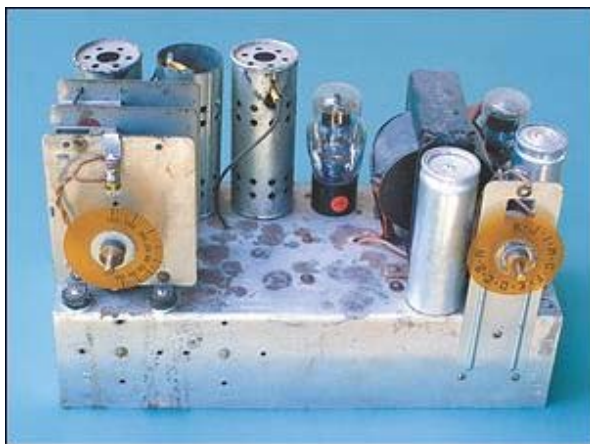
The components on the top of the chassis are all easy to access. The two 8 $\mu$ F electrolytic capacitors near the power transformer were replaced but left in-situ on the chassis to keep the set looking as authentic as possible.

The electrolytic capacitors were replaced but the 8 $\mu$ F chassis mount units were left in place to keep the set looking as authentic as possible. Several paper capacitors in critical positions, such as the grid capacitor to the 2A5, were also replaced. Some carbon resistors were out of tolerance and these were also replaced, as was R3 which was the worse for wear.

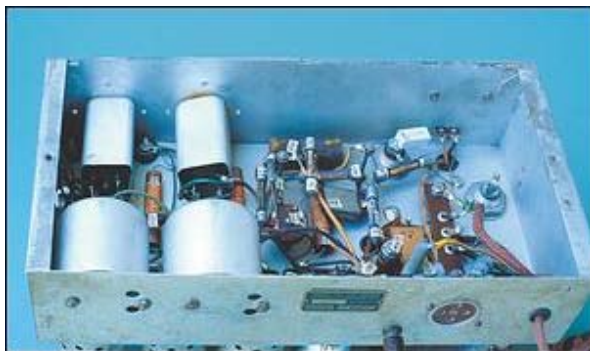
The component layout under the chassis is generally uncluttered but note that the coils sit over the top of three of the valve sockets. This makes it difficult to access components around these sockets for servicing. The IF adjustments are accessed through holes in the rear apron of the chassis.

Getting at the underside of the three valve sockets holding the 58, the two 57s and other associated components below the coils and transformers is not easy. Why did manufacturers have to make life so difficult for service personnel when a more thoughtful layout would have made life so much easier? I've seen some radios and other equipment absolutely packed to the hilt with parts and yet due to thoughtful design layout are still easy to access. On the other hand, I have seen many chassis where access is difficult, like this Airzone.

The IF adjustments are accessed through holes in the rear apron of the chassis. Two of the trimmers in the IF cans are at full HT voltage and should be adjusted using an insulated alignment tool. If you don't have the correct tool, you can cut down a large-diameter plastic knitting needle - just file a screwdriver blade on one of the pieces.
