RE CAR RADIO SERVICE MANUAL QP67A.

# Information

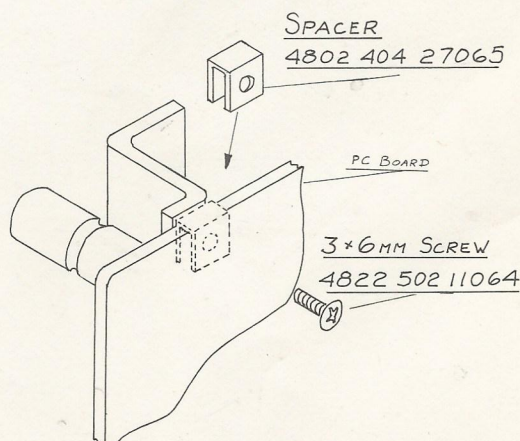
- Fault - Buzzing noise either continuously or just when the receiver is turned on.  
Cause - Poor contact between I.C. heat sink and chassis  
Cure - Replace 3x6 mm screw with new one and add spacer 4802 404 27065 as per sketch.
