Hawker Siddeley Electronics Limited

FERRIS PRODUCTS DIVISION

BULLETIN TO FERRIS CAR RADIO SERVICE CENTRES:SUBJECT:

## SLIPPING MANUAL TUNING CONTROL

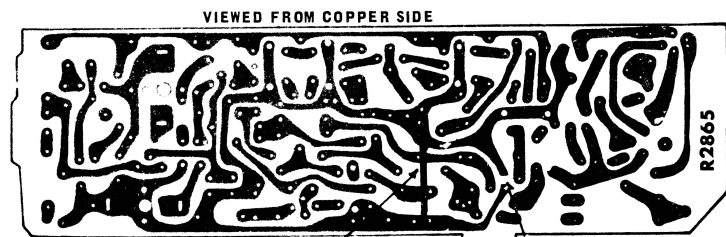
fig.4

In some Model T010 receivers a heterodyne whistle occurs at 610 KHz (2FC Sydney). In such cases the following modification should be carried out - (refer to FIG. 4).

CONNECT NEW WIRE ACROSS
