Service Manual

36910A

Correction to Service Manual/Information

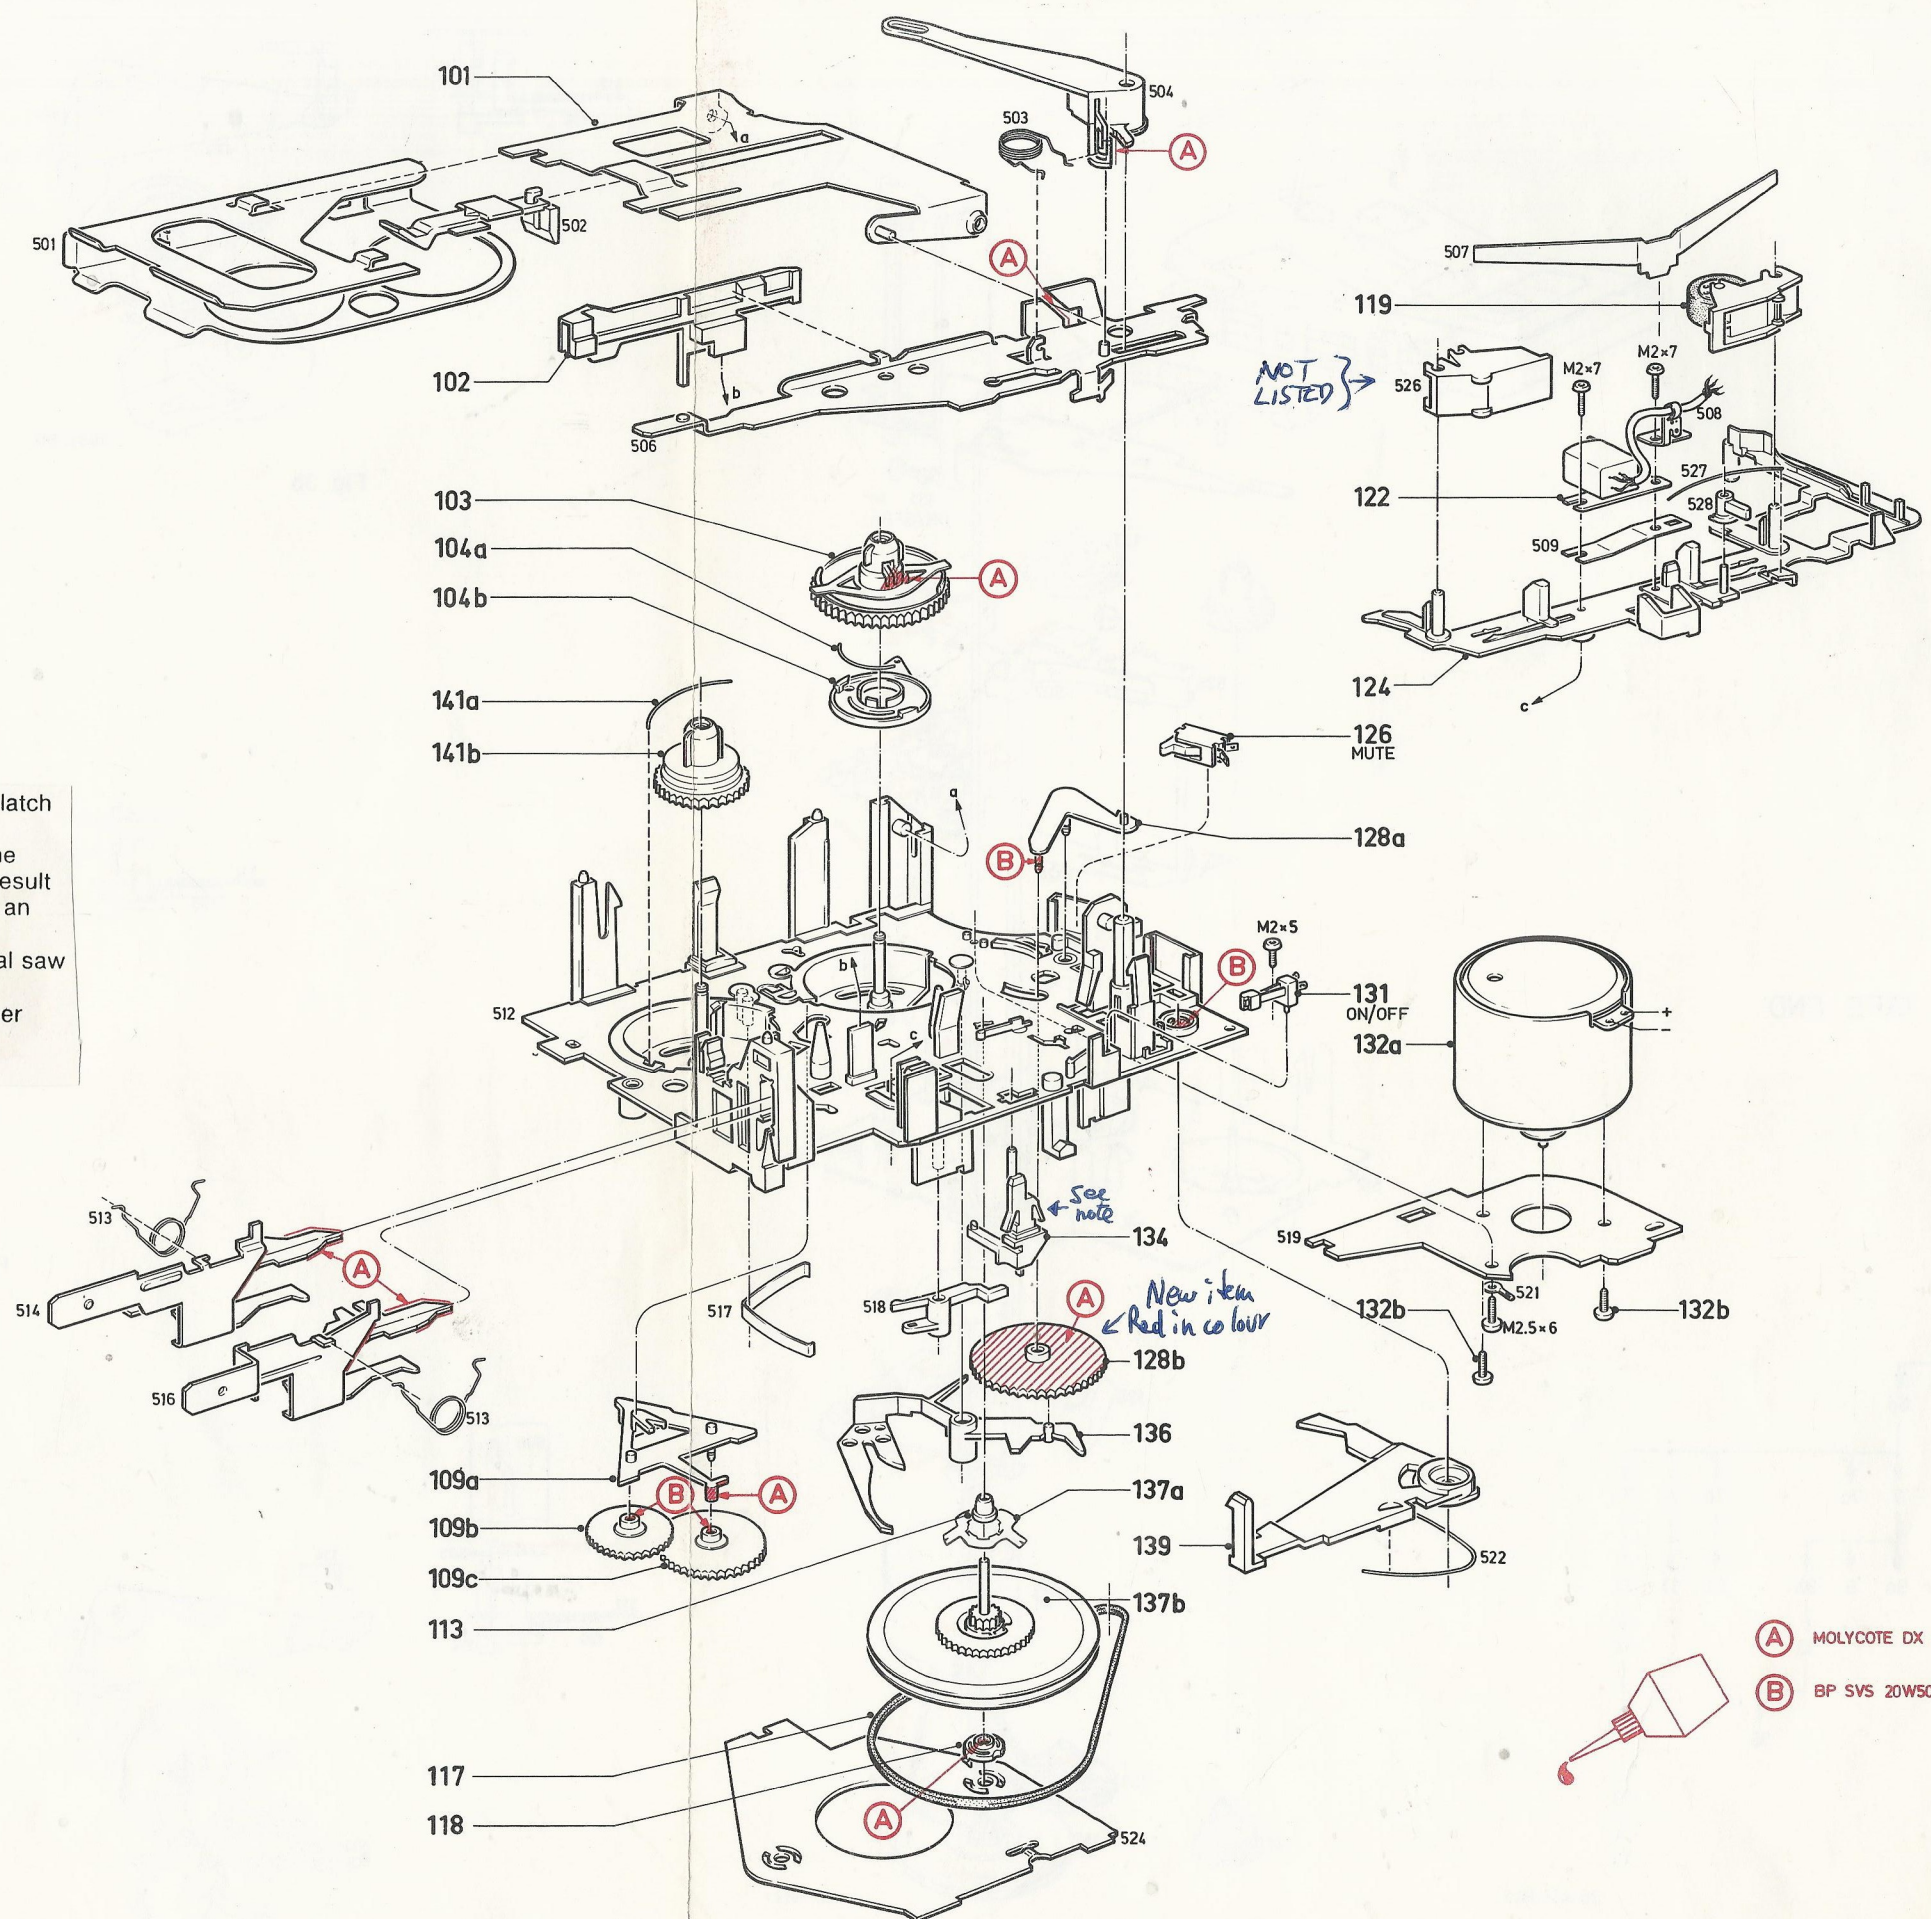
- A85-317 mentions that the production method of latch lever 134 has been changed. At the same time, however, an additional rib has been added and the clearance in chassis 512 locally increased. As a result it is impossible to mount a changed latch lever in an unchanged mechanism. There are two solutions:
 - a. Enlarge clearance in chassis by means of metal saw and a smooth file. See Fig. 1.
 - b. Replace the complete mechanism (order number 4822 701 10123).

- Enlarge clearance in chassis by means of metal saw and a smooth file. See Fig. 1.
- Replace the complete mechanism (order number 4822 701 10123).
